Section 7a Compliance Analysis

546 N. Mechanic Street
Jackson, Michigan

Performance Automotive, Inc.

February 15, 2010

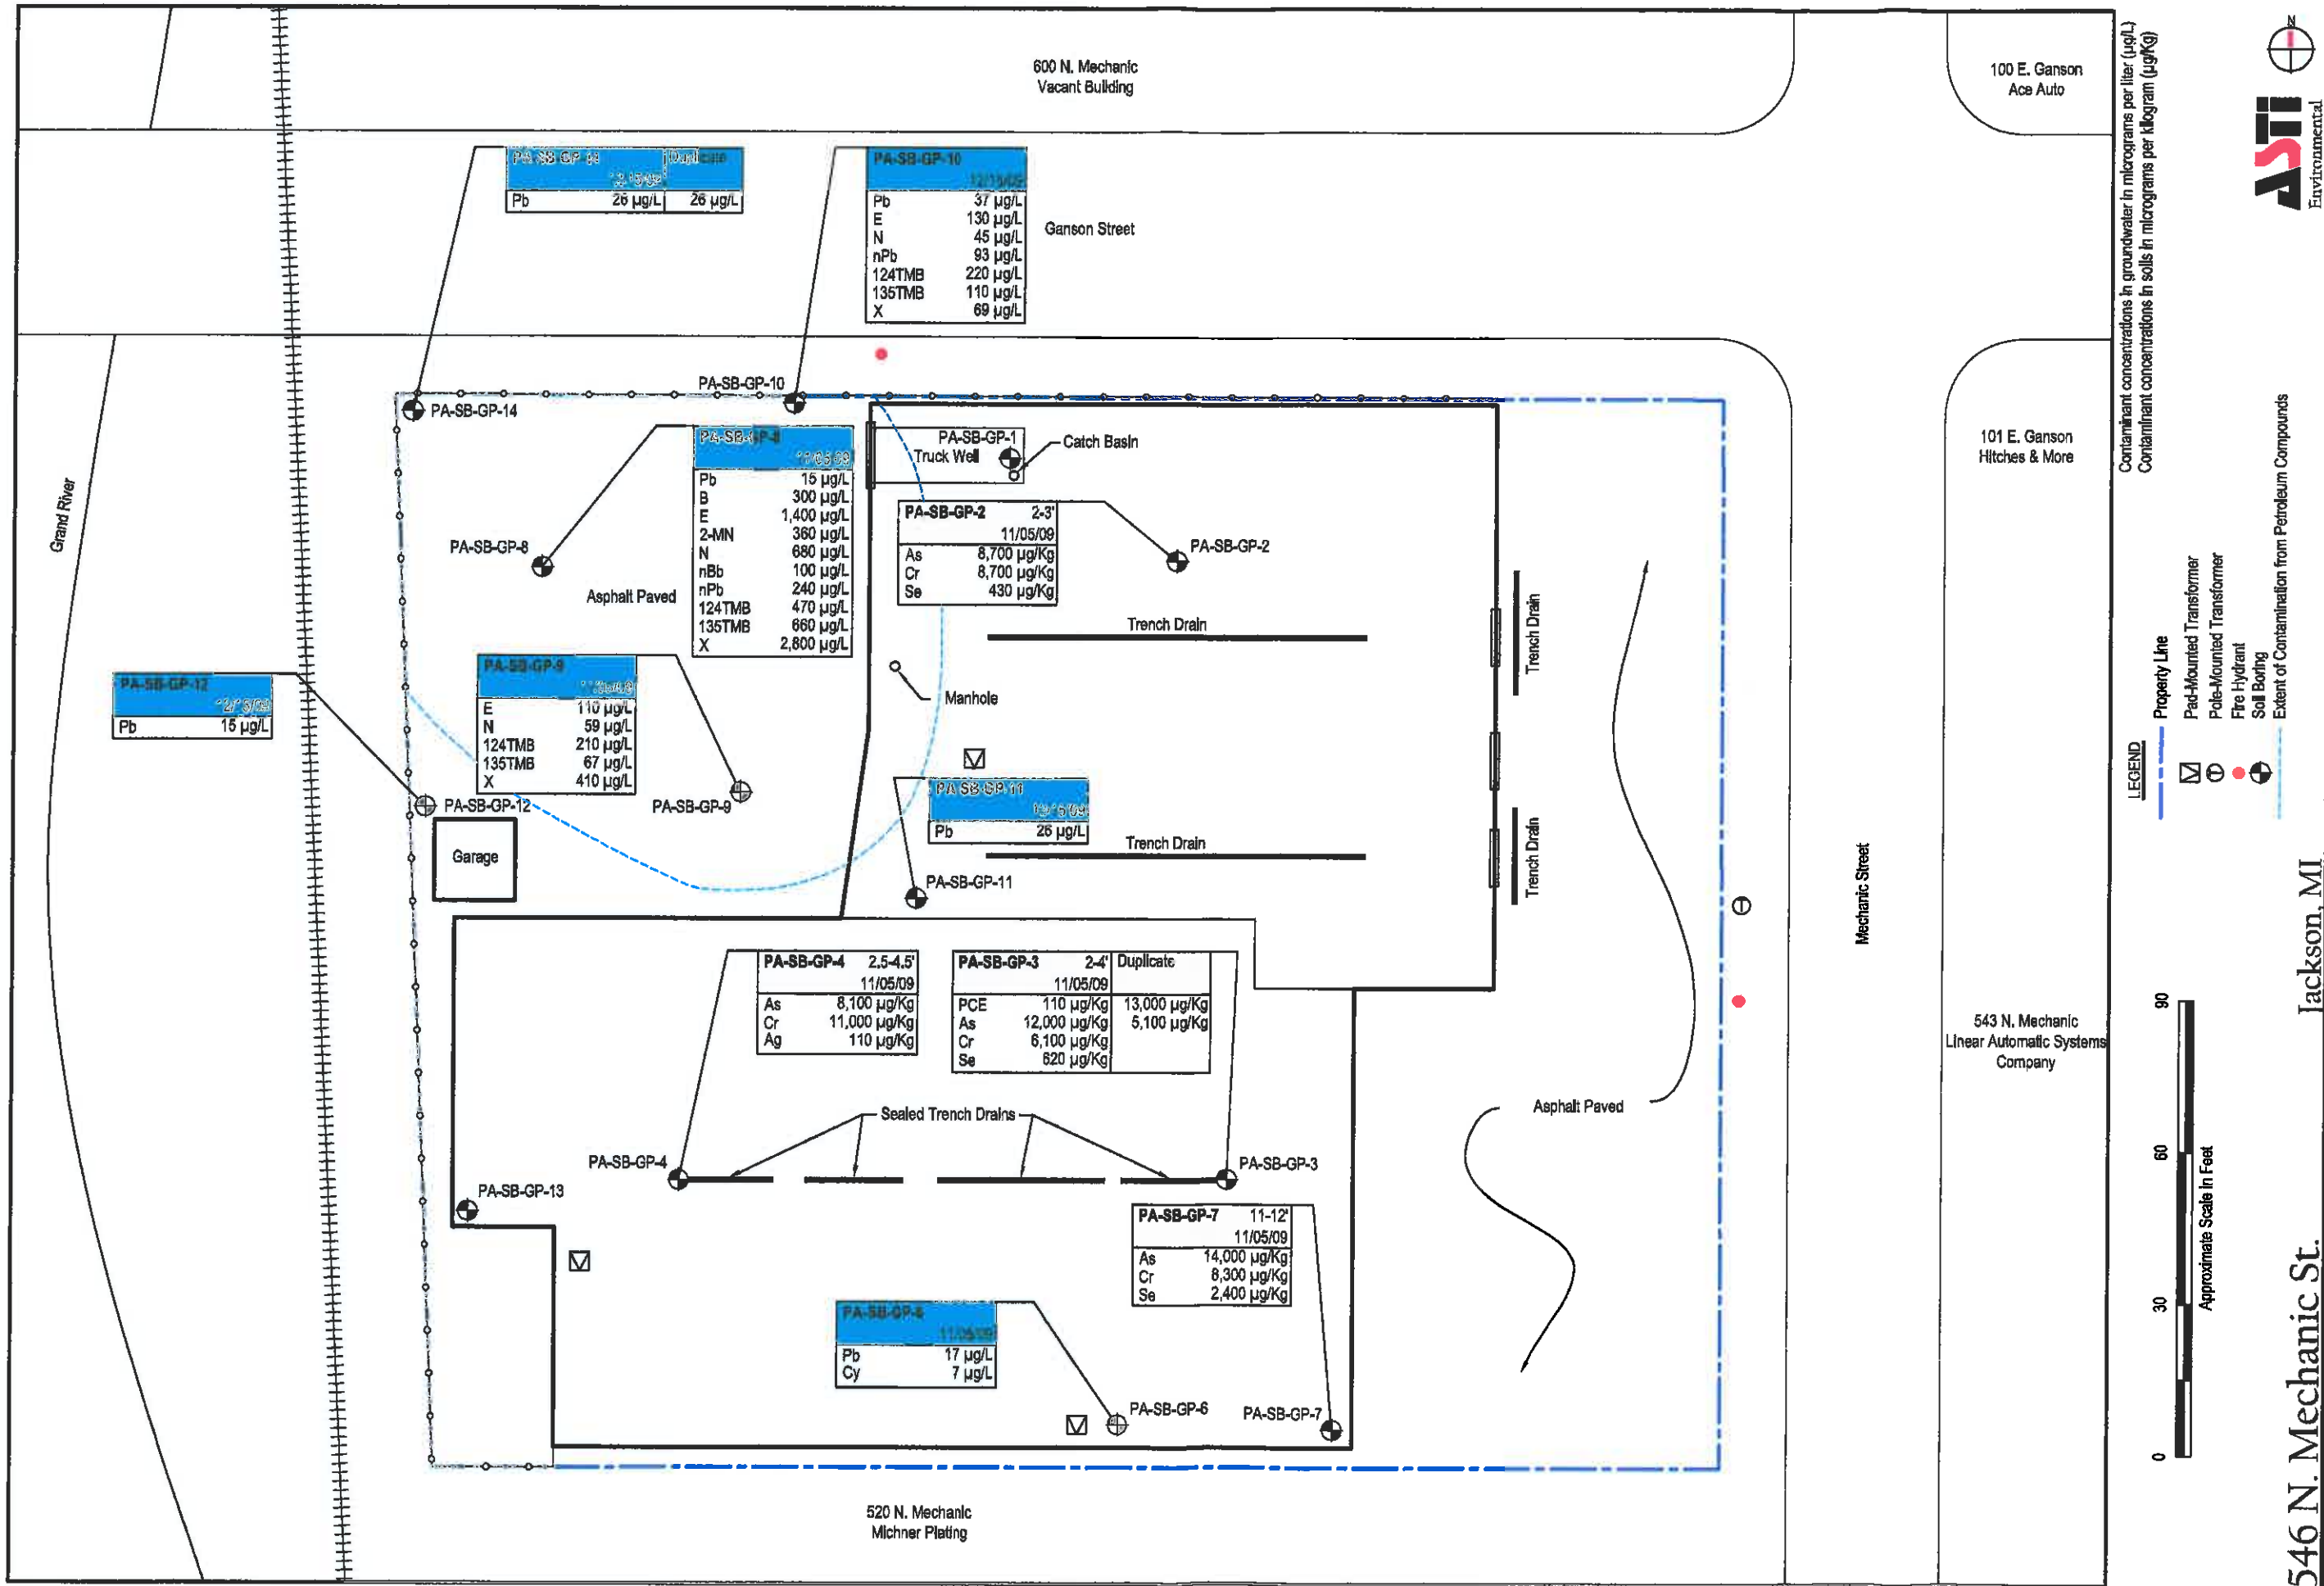
Figure 3 - Soil Boring Locations Map with Analytical Results

Soil sample analytical results are summarized on Table 1. Metals listed on Table 1 were detected at concentrations above Default Background Levels. Figure 3 illustrates detections of tetrachloroethene and metals at concentrations exceeding generic residential criteria. None of the chemicals detected in soils at concentrations exceeding generic residential criteria are characteristic of hazardous substances to be stored or used by Performance Automotive, Inc.

Groundwater contamination by VOCs is limited to the northwest portion of the Property as indicated by the absence of VOCs at concentrations exceeding generic residential criteria in temporary monitoring wells PA-GW-GP-11, PA-GW-GP-12, PA-GW-GP-13, and PA-GW-GP-14 as shown on Figure 3. The extent of groundwater contamination to the east of temporary monitoring well PA-GW-GP-10 is estimated based on the direction of groundwater flow determined in previous environmental investigations. Lead was detected in groundwater samples throughout the Property and appears to be from an off-site source. Cyanide in groundwater is limited to the southern property boundary adjoining the Michner Plating property.

Groundwater sample analytical results for compounds detected in any temporary monitoring well are summarized on Table 2. Detections of compounds detected at concentrations exceeding generic residential criteria are illustrated on Figure 3.
